# Manhole Inspection Summary

Manhole # S09MM1004MH

Insp Date: **1/20/09 4:29 PM**

**Location** Address: **4929 DENMORE AVE**

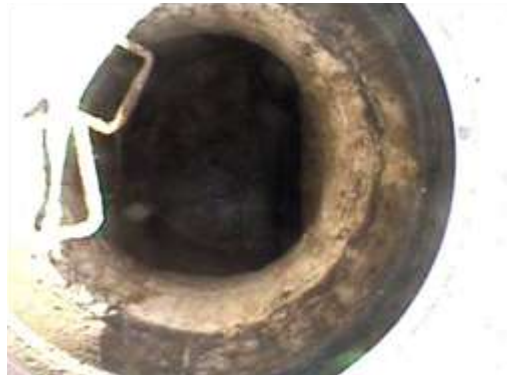
Top View

Comments **Chimney smaller than frame which is centered over chimney, but no offset condition**

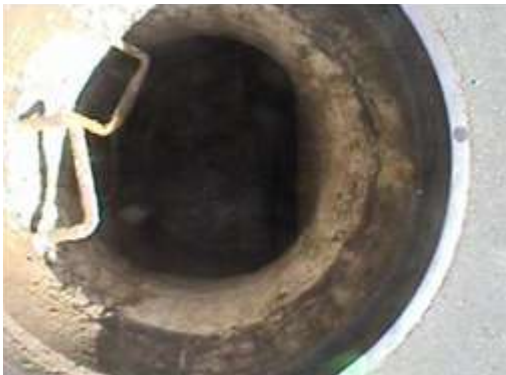
Defect 1

**Steps** Count: **6** Missing: **0** ☒ **Corroded**

CORRODED STEPS

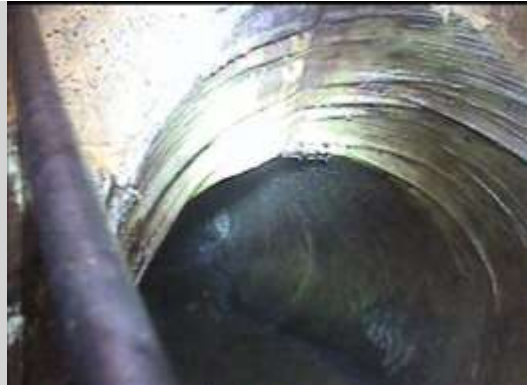
12 O'Clock Outflow

15 in. Circular Gravity Sewer  
Pipe Out @ 12 O'Clock

Pipe Material: **PVC** ☐ Pipe Lined

Invert Depth: **11.19** (ft.) Flow Characteristics: **Fast**

Infiltration: **None** Pipe Seal Cond: **Sound**

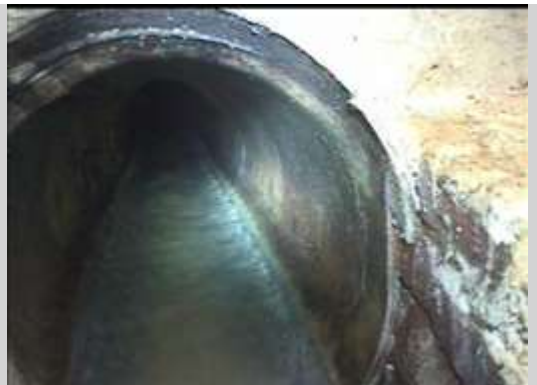
6 O'Clock Inflow

15 in. Circular Gravity Sewer  
Pipe In @ 6 O'Clock

Pipe Material: **PVC** ☐ Pipe Lined

Invert Depth: **11.00** (ft.) Flow Characteristics: **Fast**

Infiltration: **None** Pipe Seal Cond: **Sound**

Connects To: **Stub connection / abandoned**
